### **De Haro Street Community Project**

Project outline | November 2021

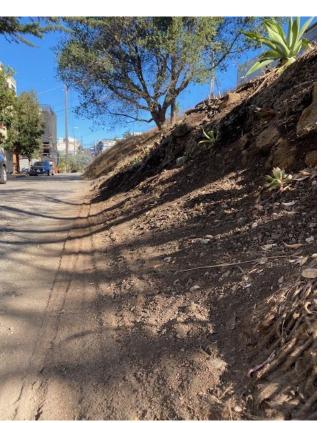
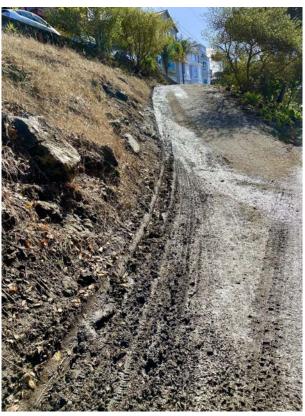
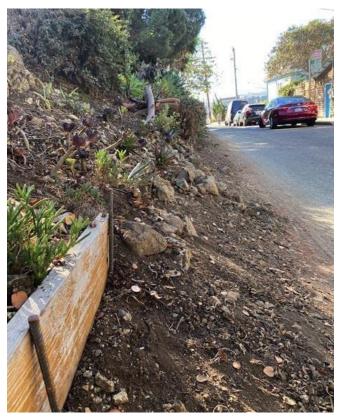
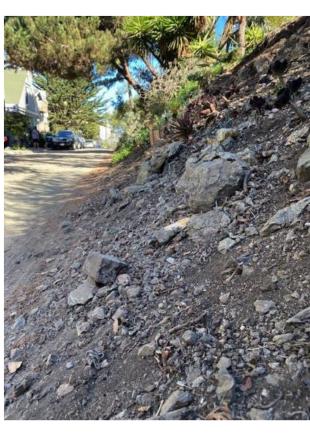
### **Lower De Haro:**

#### **Erosion and Narrowing of Roadway**

Lack of any retaining wall on the lower slope of the median creates erosion, mud slides, and excessive dirt and dust. The street is continuously getting narrower as a result of the erosion which leaves inadequate space for transit. This narrowing creates an unsafe environment for cars and pedestrians in our community. Run off flows into street bringing soils from slopes into the street and leading to significant hillside erosion and mudslides in the winter, and high dust particulates in the summer, stirred up by cars driving over the soil.

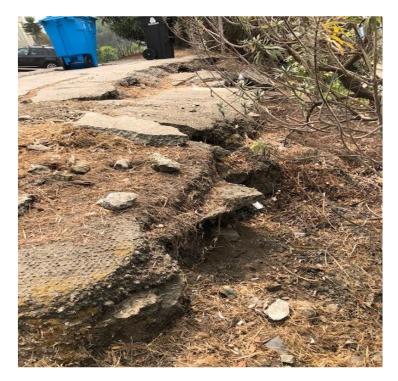
**Eroding road on Upper De Haro Street**

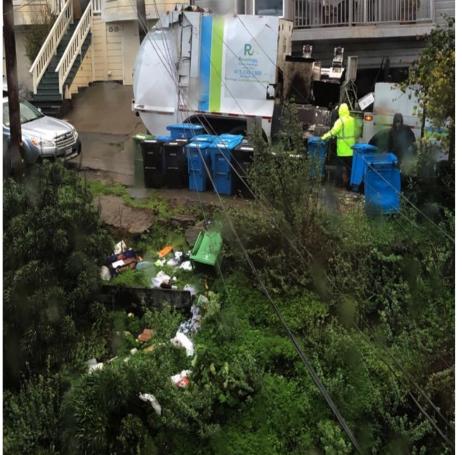
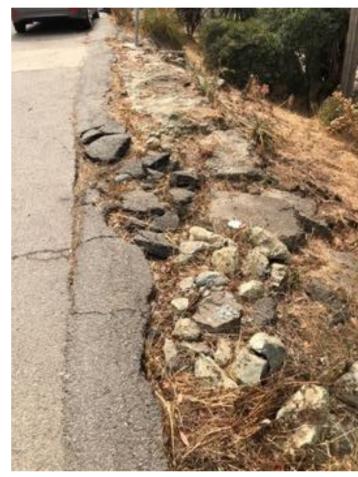
Constant flow of garbage down crumbling hillside, creating broken glass and hazardous waste issues.

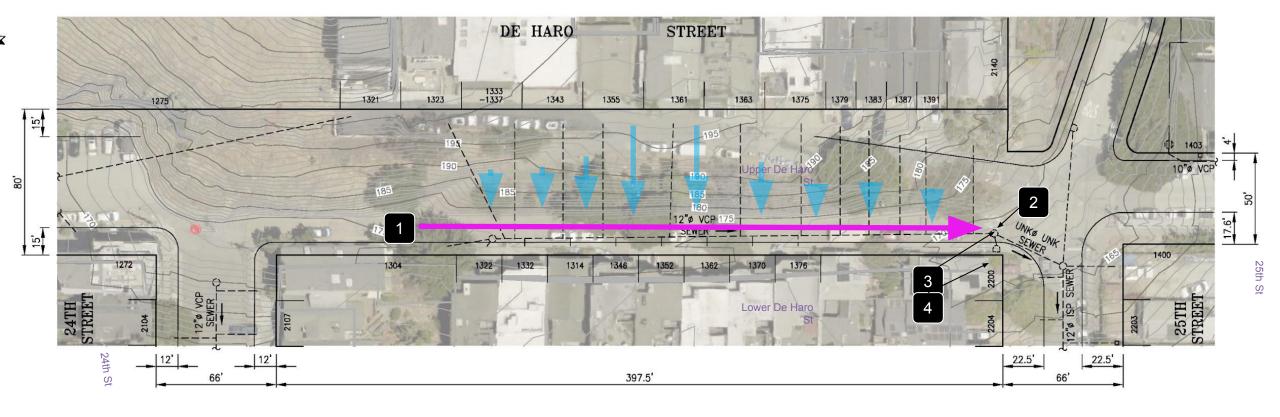
### **Existing Stormwater Flow Analysis**

- High Point of Lower De Haro (+/- 175.00)
- 2 Low Point of Lower De Haro (+/- 164.00)
- 3 Existing Sewer Manhole
- 4 Existing Curb Inlet

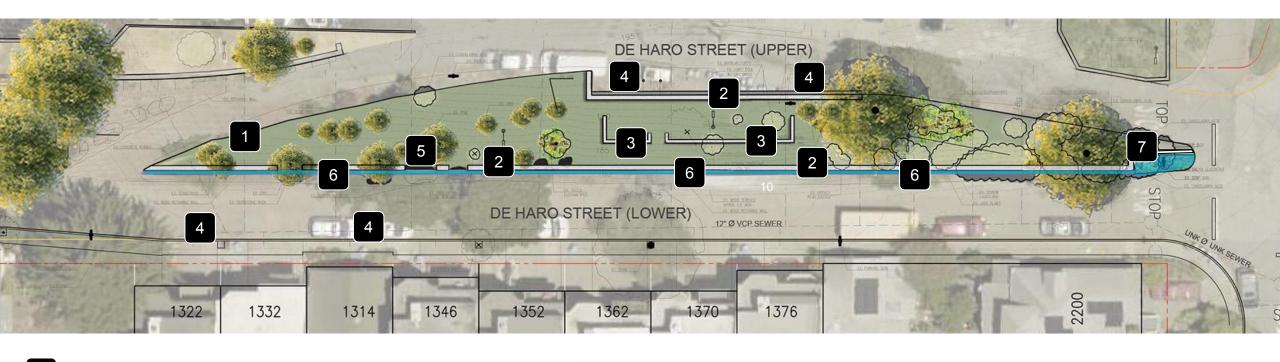
#### **Conceptual Master Plan**

- 1 De Haro Community Signage
- 2 18" wide gabion basket wall filled with serpentine like rock
- 3 12" wide gabion basket wall filled with serpentine like rock
- 4 Parallel parking

- 5 Exposed serpentine rock outcroppings interrupting gabion walls
- 6 Stormwater collection pervious bioswale / gutter at base of gabion wall
- 7 Infiltration Planter / Rain Garden
- 8 Asphalt Street

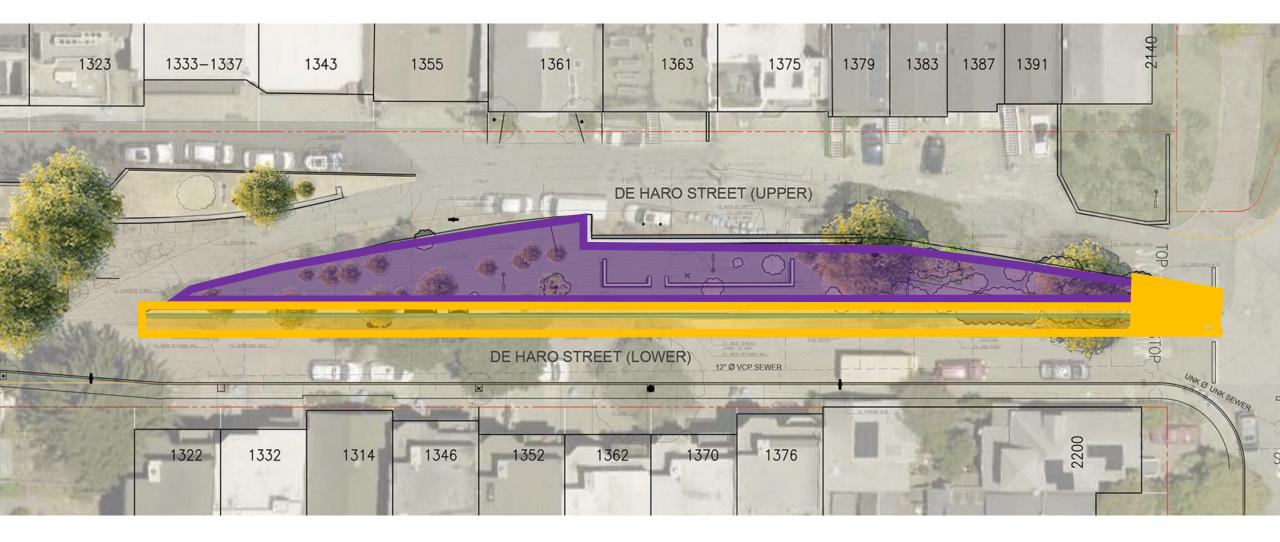
#### **Conceptual Plan – Phase 1 and Phase 2**

Phase 1 – Lower De Haro Beautification Project

Phase 2 – De Haro Median Planting and Terracing Project

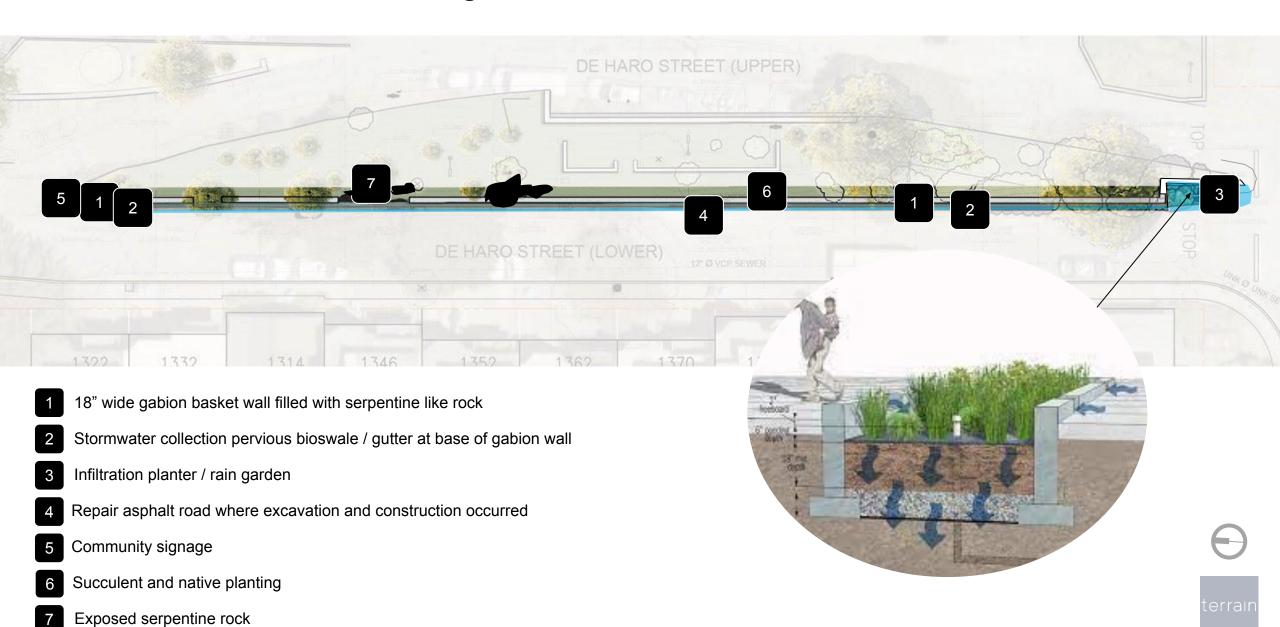
### Lower De Haro Rainwater Management and Beautification – Phase 1 Plan

### Conceptual Rendering -Phase 1

- Gabion Retaining
  Wall Captures on
  Retains Pollutant and
  Sediment Runoff
- Stormwater Runoff
  Collection Via Pervious
  Gravel Bioswale / Gutter
  at Base of Gabion Wall
  Filters Minor Runoff
  Coming Through the
  Gabion Wall and
  Conveys it to the
  Infiltration / Rain Garden
  at 25<sup>th</sup> Street
- New stone faced steps
- 4 Repaired Asphalt
- New native / naturalized planting
- 6 Existing Curb and Sidewalk to remain

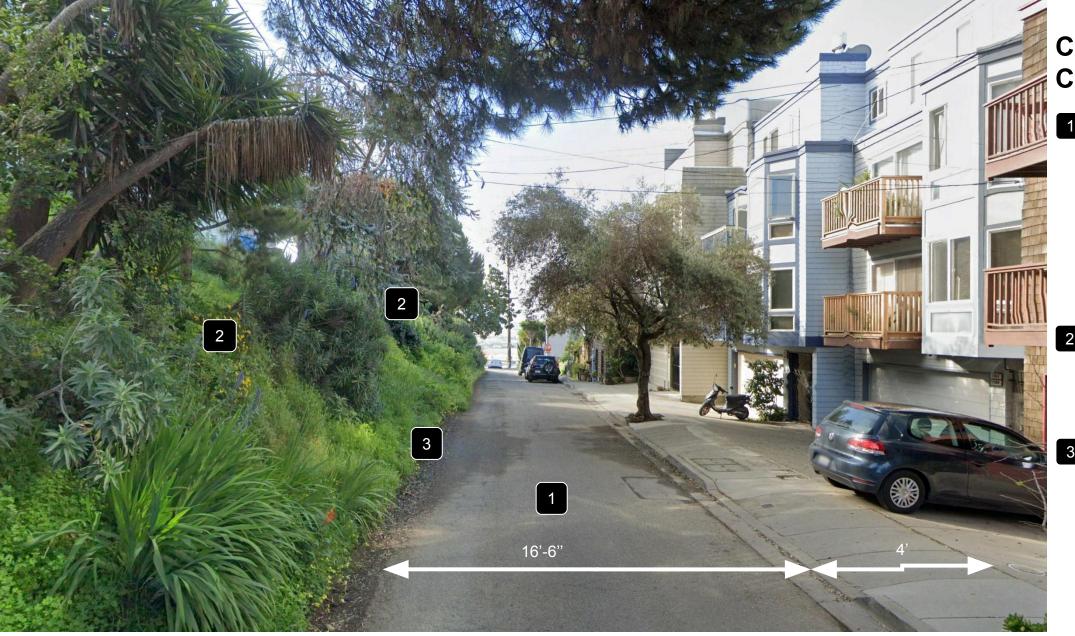
Current Conditions - Lower De Haro

- Street is too narrow making it difficult for drives, delivery trucks and bicyclists to safely navigate the street.
  Additionally, the street is too narrow to be acceptable for the Department of Public Works
- Planting is overgrown, unattractive and creates visual barriers into the hill side
- Run off flows into street bringing pollutants and sediments from Upper De Haro and median slumping slopes into the street and the storm sewer system

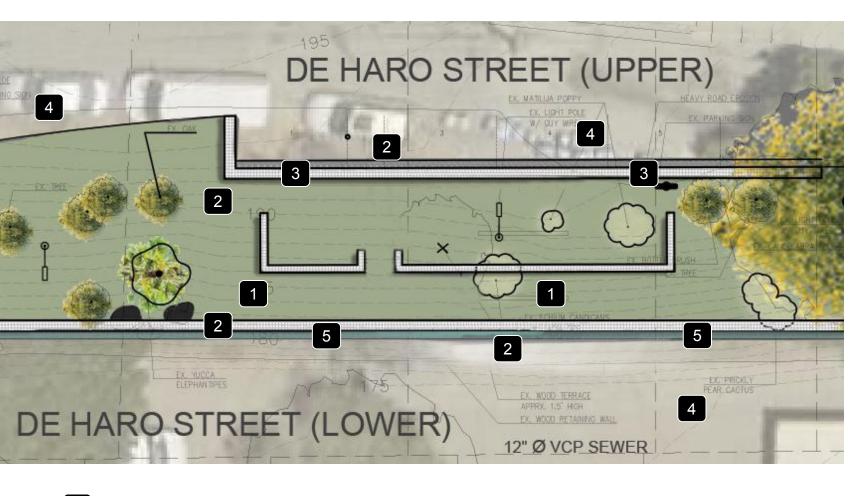
#### Conceptual Plan – Phase 2 – Rendering Upper De Haro

Phase 2 would install a retaining wall to keep the upper street from further eroding down the slope.

Together with the proposed terraces, the hillside would stop sliding and we will be able to plant to beautify the slope for all.

- 12" wide gabion basket wall filled with serpentine like rock
- 18" wide gabion basket wall filled with serpentine like rock
- Gravel drainage edge, 12" wide

- 4 Asphalt Street
- Stormwater collection pervious bioswale / gutter at base of gabion wall

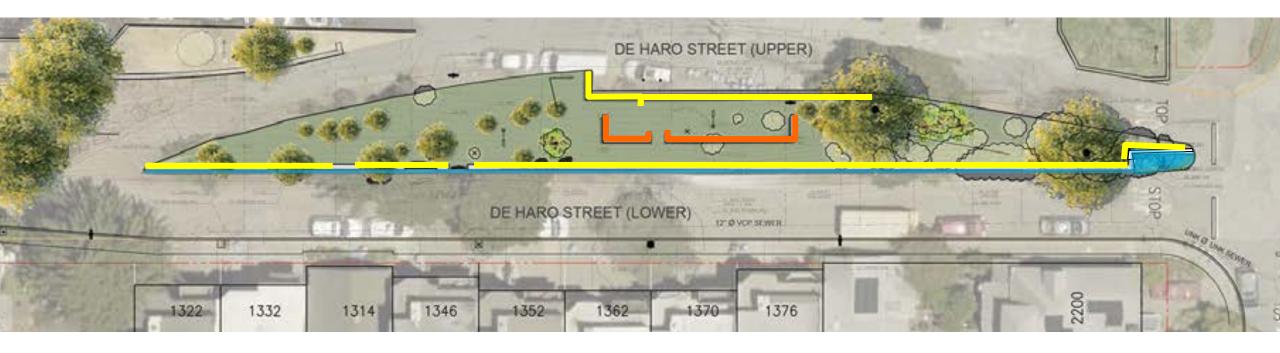
### **Wall Height Diagram**

2.5' - 3.5' Gabion Retaining Wall

3.5' - 4.5' Gabion Retaining Wall
